July 18, 2022

**Re: Building Leak Investigation Report**  
Chatham Area Public Library

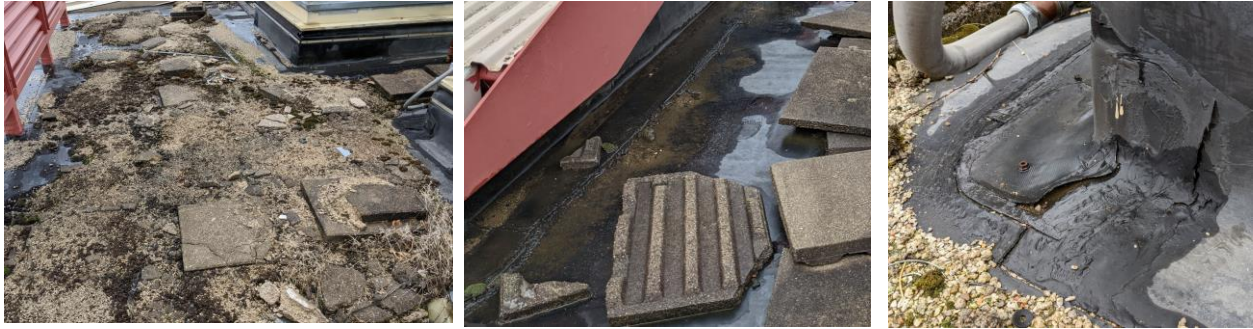
Beginning with the roof assembly issues, we found deteriorated roof pavers and failed membrane flashings. The original built-up roofing membrane systems have been replaced with EPDM (a.k.a. rubber) and the existing thirty-eight year old standing seam metal roof system (SSMR) is still in place.

Several of the concrete pavers and even some concrete downspout splash pads have failed and disintegrated into gravel. Once this occurs, water gets trapped on the roof surface and the drainage systems get clogged. Obstructions to gutters, downspouts and area roof drains create ponding water which promotes vegetative growth, attracts insects, membrane discoloration, staining and water infiltration through the membrane itself.

Foreign debris must be removed from all of the roof surfaces, drains, and gutters. All punctures, open seams, failed sealant joints, and deteriorated neoprene fasteners must be replaced. These and all other imperfections must be corrected immediately to prevent further water infiltration and will serve as a temporary correction until the extent of damage can be further evaluated through destructive measures.

Due to the estimated age of the existing roofing assemblies, all membrane (EPDM and TPO) systems are likely beyond their anticipated lifespan and will require either full replacement and/or application of a roof coating system once all wet areas have been rectified. The SSMR will not require total replacement, but rather corrections as noted above as well as application of a coating system or supplemental secondary roofing installed directly above.

Infrared (IR) thermal imaging scans should be conducted at all membrane roof areas to determine if and where wet insulation is present. If wet areas are identified, they will require removal and replacement prior to installation of new roofing membrane. For the SSMR, since both the exposed layer and under roof deck are both metal, this assembly is virtually impossible to perform accurate IR scans to either from the top or the underside. Typically, if there are any areas of water infiltration on the SSMR, they will be located in transitions and flashings which can be disassembled and corrected during the fastener and sealant replacement work.

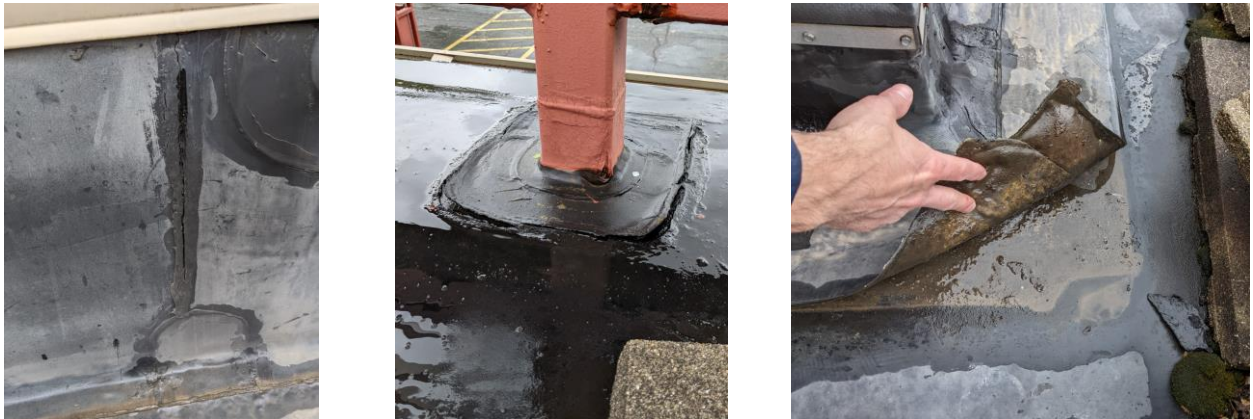
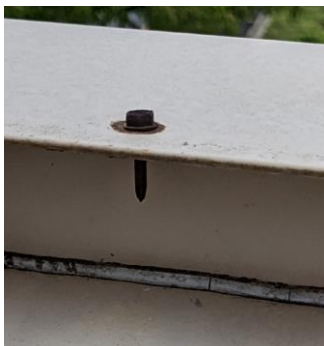
There are open base flashings at various roof top equipment curbs and various other roof penetrations (i.e., steel supports for the screens, plumbing pipes, etc.).

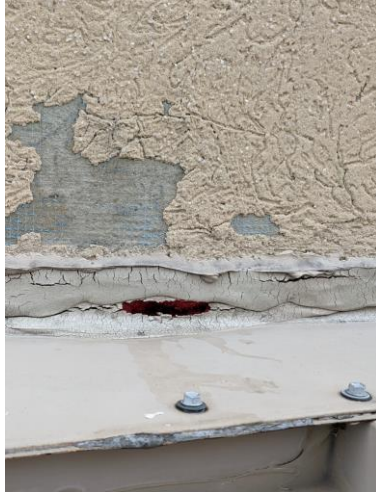
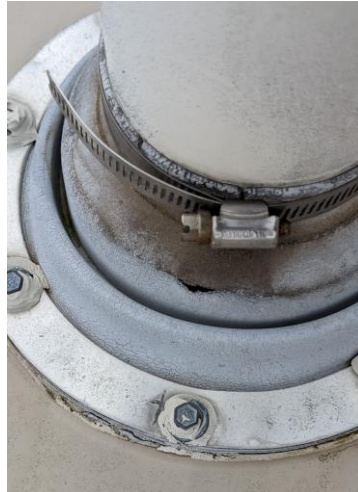
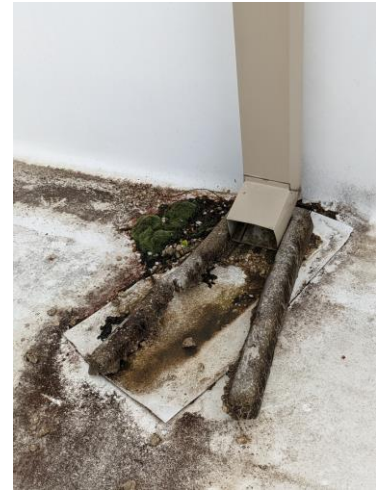
Leaks have been reported on the SSMR in several places. Other than chalking of the painted finish, the SSMR surfaces appear to perform well. and all appear to be due to deteriorated sealant and fasteners.

Since the base flashings, sealant and neoprene washers have failed at any of these locations there is virtually no protection from water infiltration caused by normal precipitation. Wind driven rain is even more troublesome at these locations without protection.

Several layers of sealant were discovered, many of which are cracked, deteriorated and failing. For sealant to be effective, it must be installed continuous, bonding to all surfaces. Old sealants and residue must be thoroughly removed prior to the application of new sealant to provide proper bonding. To make the situation worse, there are no provisions for drainage of the EIFS present at any transitions to the SSMR.

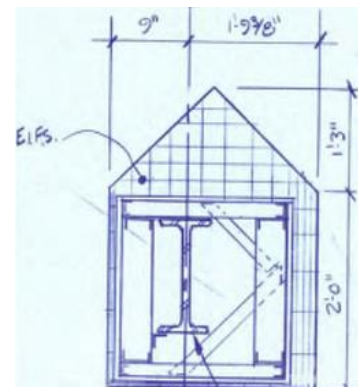
The last EIFS condition observed are at the east to west spanning "Architectural Elements" with concrete buttress bases, located on the north building façade. Again, this appears to have been clad without a drainable EIFS system and therefore there are no provisions for either ventilation or water to evacuate the system. Other than discoloration and accumulation of dirt and other organic material on the surface, this EIFS is in relatively decent shape. This is likely a direct result of their curved and pyramidal geometry.

EIFS at the architectural elements can either be cleaned and refurbished or replaced its entirety. If refurbishment is selected proper ventilation will need to be installed on the underside and run continuous from the base to the highest points, respectively. Expansion joints will need to be added where surface cracks are present, which will require additional framing and patching.

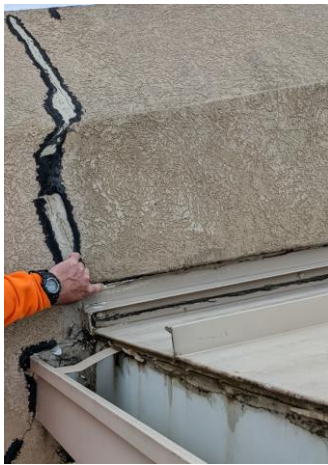
Discoloration of the EIFS and lower brick will continue to occur at the architectural elements without implementation of regularly scheduled cleaning. The following images illustrate the discoloration and terminations at the concrete buttress base.

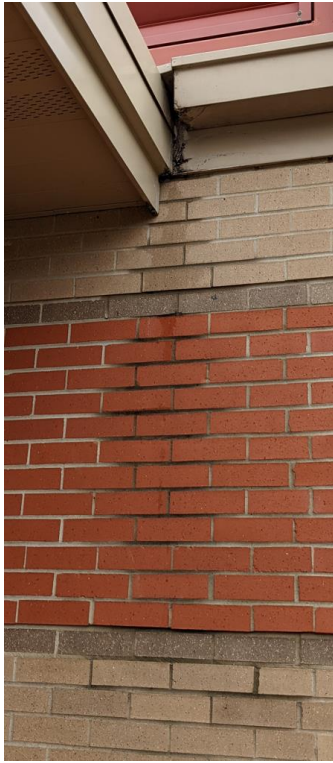
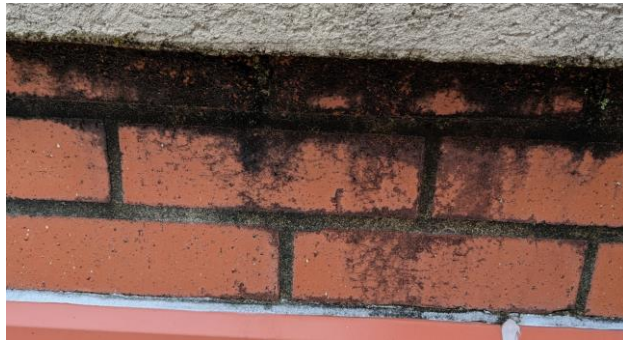
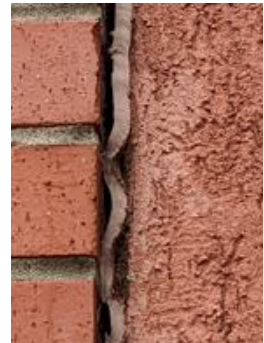
No specific exterior wall issues were reported regarding water infiltration; however, we did discover areas where sealant has failed and conditions where water runoff has stained the masonry below.

There were reports of water infiltration at the two planters located at both of the east entrance door locations. The water proofing membrane originally installed in 2007 is still in-place, but torn, allowing water to become trapped below weeps that were designed to let water escape. The weeps that do exist appear inadequate and possibly clogged. No records of new waterproofing being installed have been discovered, but staff did suggest there have been water

Finally, we recommend cleaning and sealing of the exterior masonry walls and replacement of all backer rod and sealant adjacent to and within the masonry wall assemblies. To correct water infiltration at the planters we recommend replacement and re-routing of the downspout drainage piping and installation of a waterproofing membrane system on the interior of each planter condition. An alternative would be to remove the planters in their entirety; however, this will require repair and treatment to the exposed masonry located directly behind the planters themselves.
