Facilities Assessment
Chatham Area Public Library (CAPL)

The purpose of this assessment is to document existing conditions and provide the library staff with a comprehensive list of maintenance items and suggested improvements. The intent is then to establish a proactive approach for maintaining the library facility and budgeting for any relevant corrective or replacement work. We have also included any deficiencies we observed in relation to the function and use of the facility near the end of this assessment report.

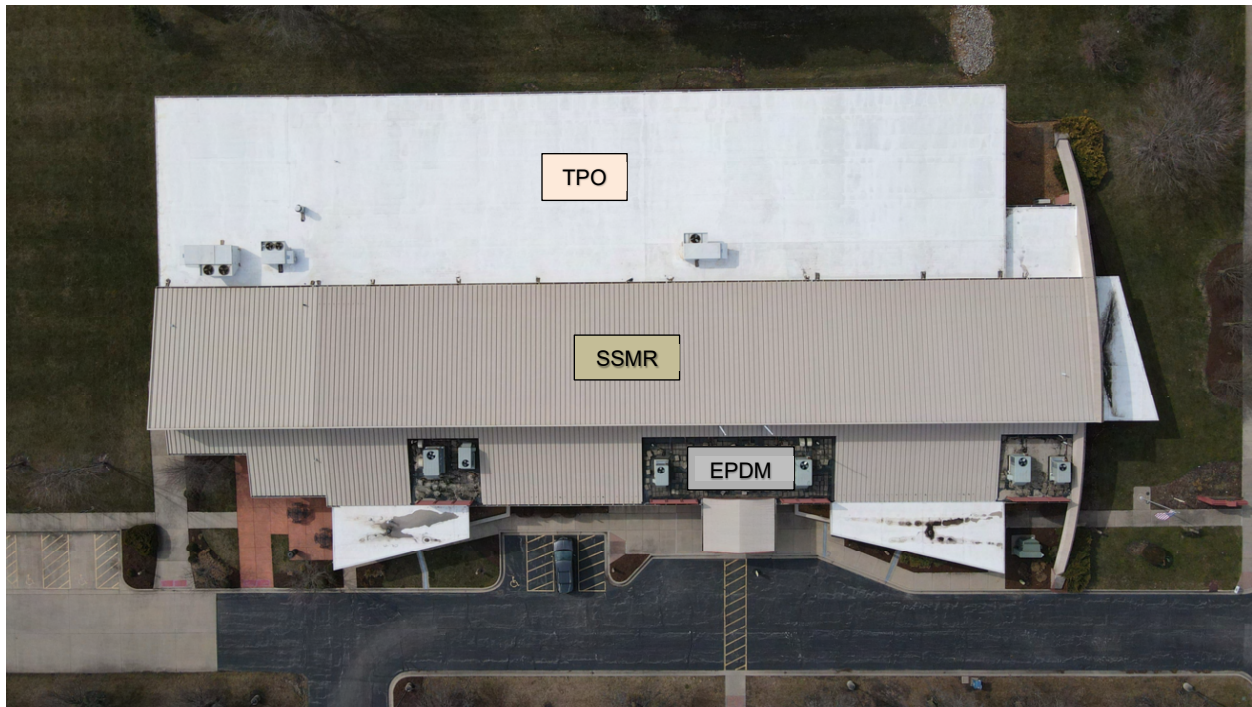
Image B (aerial image looking directly down)

With the exception of EPDM and SSMR flashings all existing roofing systems appear to be in fair condition. Areas of concern can also be corrected by full system replacement, installation of a re-roofing system (i.e. fluid-applied coating, membrane overlay, etc.) or a combination of both. Anticipated costs for this work will range anywhere between \$17 - \$25 per square foot of roof area depending on the particular system, availability of materials and current local construction environment.

From the below illustration (Image B), the various roofing systems can be seen; white areas illustrate the TPO systems from the 2007 building addition, tan areas illustrate the SSMR systems, and the remaining areas located on the east side of the building show where the EPDM roofing systems are located along with the majority of RTU equipment.

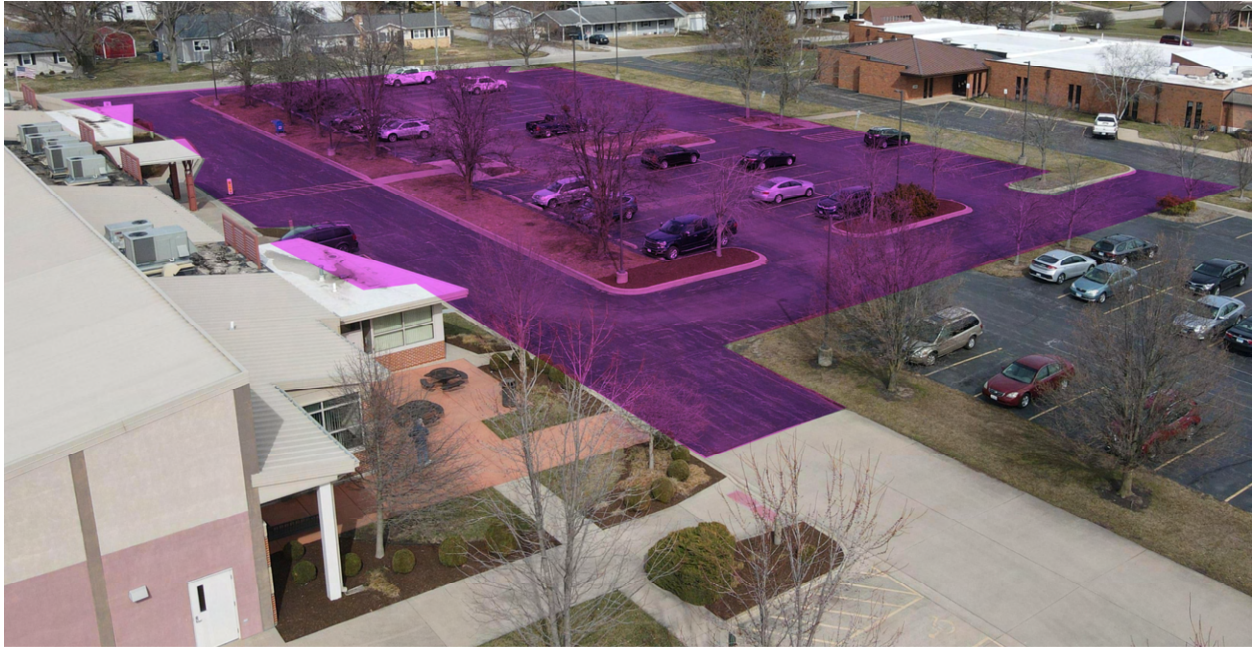
Image C (purple highlighted areas are included in projected costs included herein)

It is our understanding that CAPL shares the larger portion of asphalt parking with St. Joseph's Catholic Church. For the purpose of this report, we will reference the entire parking lot in condition only. All associated costs for repair and/or replacement will be limited to approximately 88 parking spaces and associated approaches from the north along E. Spruce St, and the main access drive located directly east of the library. (See image C below)

Surface cracks are typical in asphalt parking lots and with proper maintenance, the surface has the ability to last between 20 and 30 years. We were unable to locate records of asphalt sealer being applied, overlay or replacement; however, evidence of patching and repair work is apparent in several drive lane locations. All that being said, the asphalt paving has reached the end of its anticipated life expectancy and requires full replacement and/or a combination of overlay and resurfacing.

Associated costs typically range between \$6 – \$9 per square foot of paving area depending on the soil and sub-base conditions located directly beneath the asphalt. The complexity and configuration of the parking areas also contribute these overall costs. In addition, asphalt requires application of a sealcoating every 2 – 3 years, maximum. During this process, cracks are sealed and/or repaired prior to applying the sealer ensuring the surface will last up to, and often beyond, the 20 – 30 life expectancy.

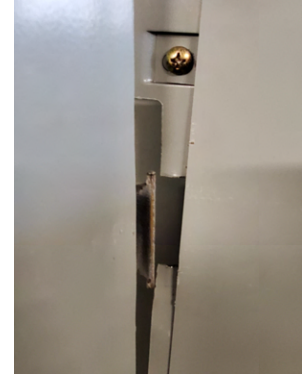
Image D (Hinge)

Electrical panel LP-E1 has a broken hinge on the door assembly. (See image D). Although unlikely, there is a greater chance for injury, breaker failure and even fire when an electrical panel is not properly secured and or protected. Costs associated with correcting this should be limited to the electricians labor involved to remove the panel cover and door assembly, fix the damage hinge and reinstall the cover and door assembly. If the electrician determines it cannot be repaired, then it will be subject to fabrication of a new panel cover and door assembly.

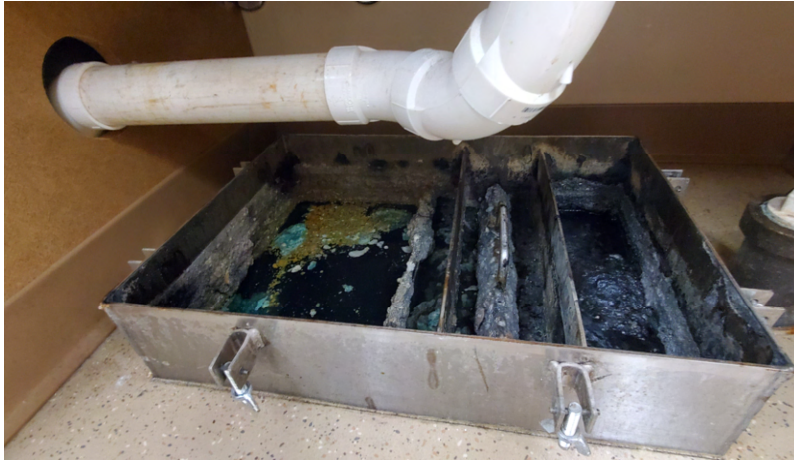
Image E (Grease Trap)

5. Grease Trap During our site visits a foul odor was present in the south end of the facility. After further investigation, we discovered the kitchen grease trap needs cleaned out and the lid seals may require adjustment or even replacement. It appears the kitchen was originally designed with the anticipation of more frequent food preparation, which is not how it current is utilized. There are several rules

of thumb for maintaining a grease trap: first rule, if you can smell a foul odor, then it should be cleaned; second, if there is a low volume of drainage the trap is less likely to be flushed out through normal use and it will require more frequent cleaning; third, if more than 3 months' time have passed, the trap should be cleaned. Since this space is utilized more for storage than food preparation it likely has resulted in neglect of the grease trap maintenance. Cost will range significantly depending on whether this work is performed by maintenance staff or by a licensed plumbing contractor, but should range between \$400 - \$1,000 per cleaning.

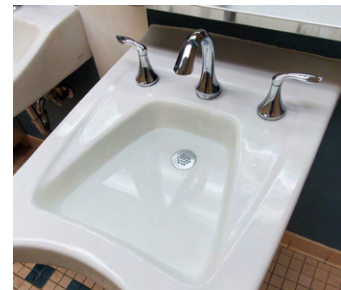
Image E (Sink)

The Men's accessible sink does not drain properly. Typically this is due to a clogged drain and can be corrected by simply having the drain piping augured out to remove any build-up or obstructions. Once again, costs for this will vary depending on wither work is being performed by CAPL maintenance staff or a licensed plumber, but should range between \$400 - \$900 per drain.

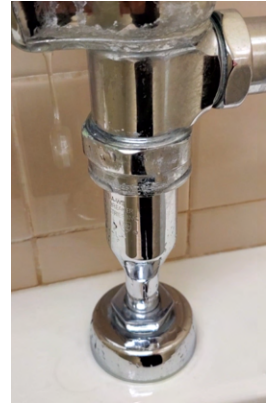
Image F (Flush Valve)

The Men's urinal leaks when in operation, which likely means the seals have failed or the assembly needs replaced. The flush valve assembly itself will vary in cost depending on the manufacturer and where it's purchased; however, installation will be subject to the same labor mentioned above. Repair/replacement costs to replace a flush valve assembly will range between \$900 - \$1,600.

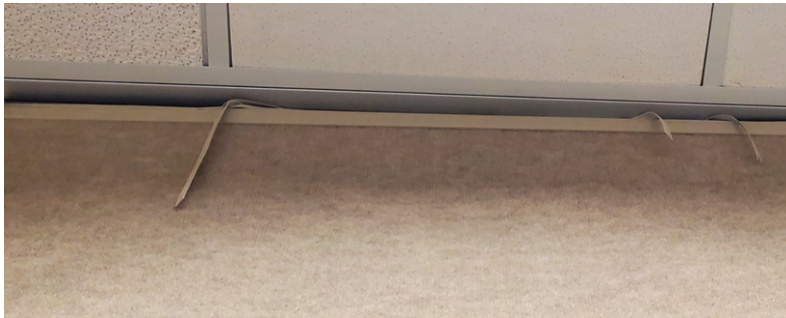
Image G (Moveable Partition Seals)

The moveable partitions located in the southwest meeting room area are original to the 2007 building addition/renovation project. Other than normal signs of use on some of the panel faces, the partition structure appears to be in sound and functional condition. The top and bottom seals are failing on several panels and should be replaced, and costs should range between \$6,000 - \$9,500.

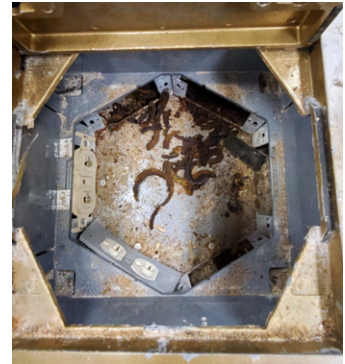
Image H (Floor Box)

In the public meetings rooms, several of the floor boxes housing electrical power and data connections contain typical dirt and debris. We also discovered significant amounts of rusted metal remnants that appear to be deteriorated electrical accessories (i.e. conduit, connectors, etc.). There were no frayed electrical wires or loose connections visible during our inspections which leads us to believe this may be construction debris from when the building addition was originally constructed or from various other modifications. Maintenance staff should be able to vacuum out all of the debris from each floor box, limiting any associated costs.

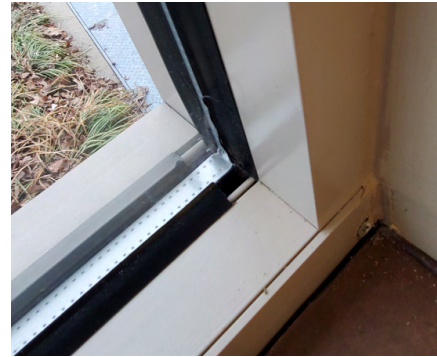
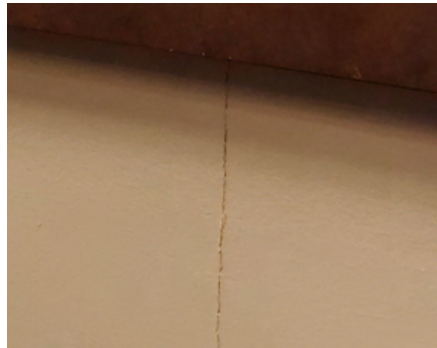
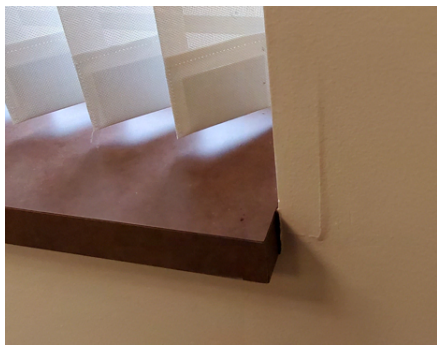
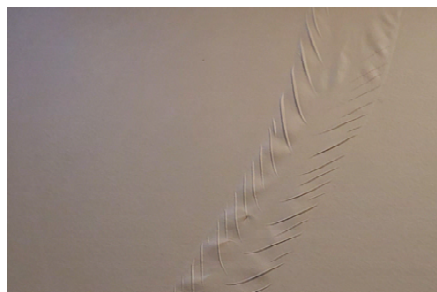
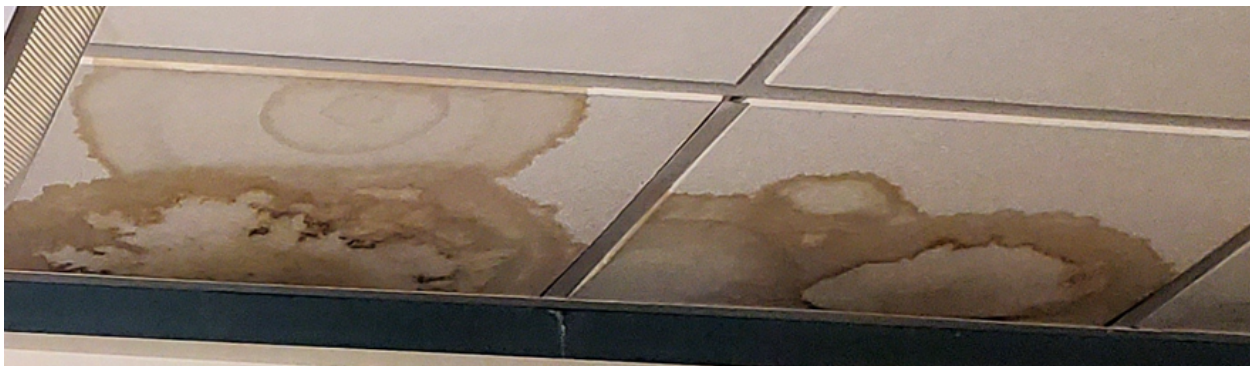
There are surface cracks are present around the exterior windows in the north meeting room. This can be corrected by installing an expansion joint(s) above and below the window opening, allowing movement of the GWB and preventing this type of surface cracking.

There is exposed corner bead trim around the window perimeter and likely due to building movement, humidity or moisture.

There are also various locations where ceilings and acoustic ceiling tiles have been damaged because of water infiltration.

Corrective work should include painting of the entire wall/ceiling surface(s) and replacement of all damaged ceiling tile. Our suggestion is to have all of the ceiling and GWB corrective work performed by the same carpentry and painting contractor.

Combining all of this work should minimize costs, which should range from between \$8,000 and \$14,000.

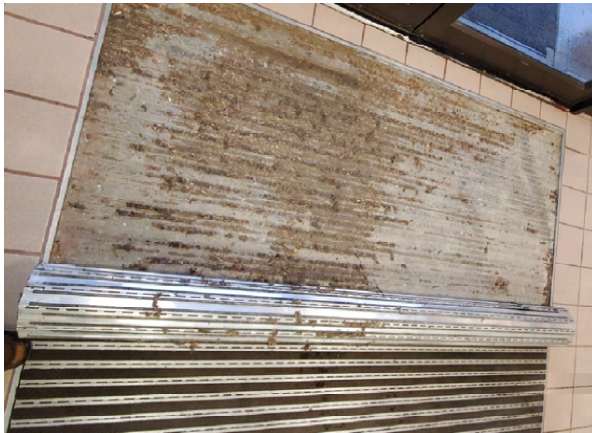
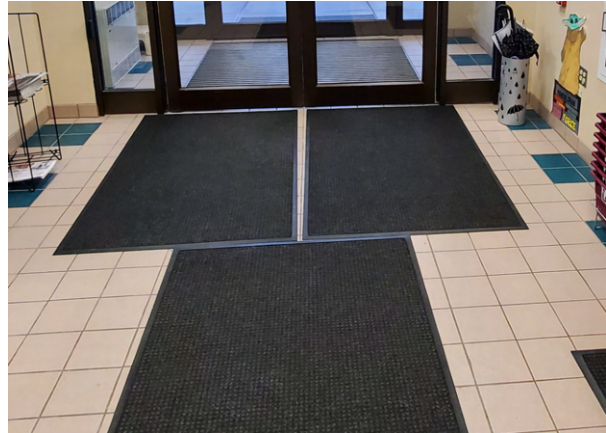
During our visit, the recessed walk-off mat in the vestibule floor located at the main entrance had a significant amount of dirt and debris in it during our visit. The primary purpose of a walk-off mat is to minimize the risk of slips or falls caused by dirt and moisture. By locating the mat directly inside the main entrance with the highest volume of foot traffic, the idea is to provide a place for dirt and moisture to fall from our shoes. However, if the mat is not cleaned regularly, you end up with a build-up of debris which negates the use of a recessed mat. The image below illustrates how much debris was present during our visit and how the mat can be removed for cleaning. How often this is cleaned will vary greatly depending on the season and amount of traffic received, but it is recommended to vacuum this a minimum of once every couple of weeks.

We also noticed additional floor mats located directly inside the vestibule and over the ceramic floor tile in the Lobby. The presence of additional walk-off mats is likely be due to moisture on the ceramic tile, which can be extremely slippery when wet. Regularly scheduled cleaning of the recessed walk-off mat may potentially reduce the frequency of having these floor mats laundered.
