July 18, 2022

**Re: Building Leak Investigation Report**  
Chatham Area Public Library

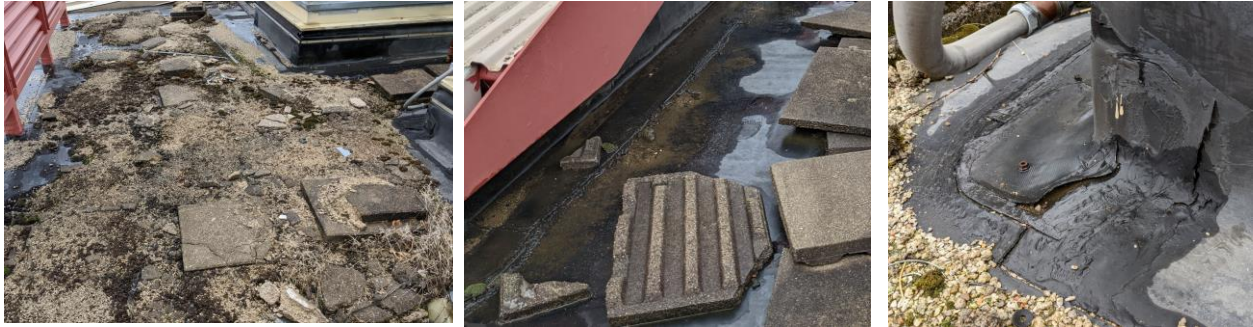
Beginning with the roof assembly issues, we found deteriorated roof pavers and failed membrane flashings. The original built-up roofing membrane systems have been replaced with EPDM (a.k.a. rubber) and the existing thirty-eight year old standing seam metal roof system (SSMR) is still in place.

Several of the concrete pavers and even some concrete downspout splash pads have failed and disintegrated into gravel. Once this occurs, water gets trapped on the roof surface and the drainage systems get clogged. Obstructions to gutters, downspouts and area roof drains create ponding water which promotes vegetative growth, attracts insects, membrane discoloration, staining and water infiltration through the membrane itself.

Foreign debris must be removed from all of the roof surfaces, drains, and gutters. All punctures, open seams, failed sealant joints, and deteriorated neoprene fasteners must be replaced. These and all other imperfections must be corrected immediately to prevent further water infiltration and will serve as a temporary correction until the extent of damage can be further evaluated through destructive measures.

Due to the estimated age of the existing roofing assemblies, all membrane (EPDM and TPO) systems are likely beyond their anticipated lifespan and will require either full replacement and/or application of a roof coating system once all wet areas have been rectified. The SSMR will not require total replacement, but rather corrections as noted above as well as application of a coating system or supplemental secondary roofing installed directly above.

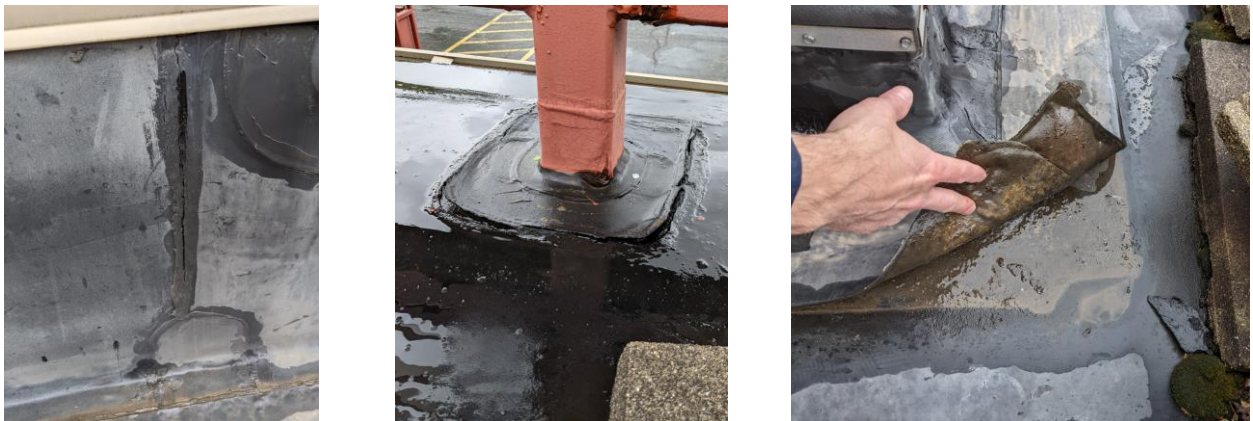
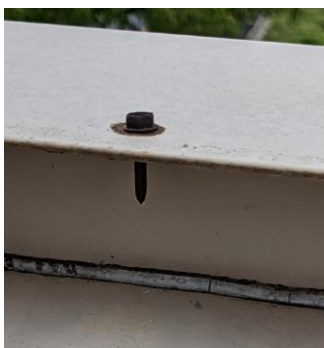
There are open base flashings at various roof top equipment curbs and various other roof penetrations (i.e., steel supports for the screens, plumbing pipes, etc.).

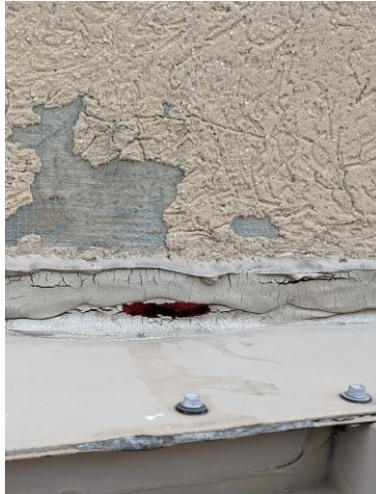
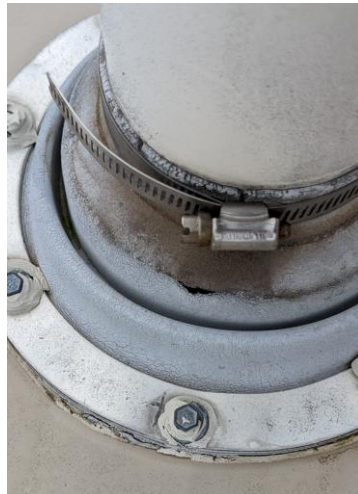
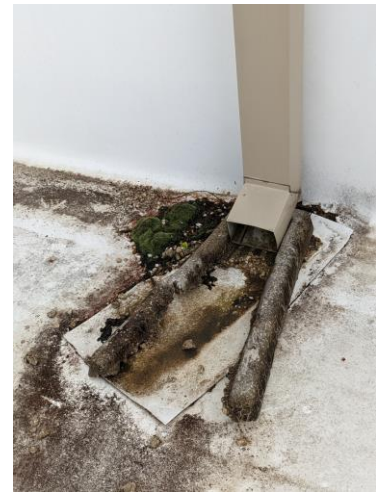
Leaks have been reported on the SSMR in several places. Other than chalking of the painted finish, the SSMR surfaces appear to perform well. and all appear to be due to deteriorated sealant and fasteners.

Since the base flashings, sealant and neoprene washers have failed at any of these locations there is virtually no protection from water infiltration caused by normal precipitation. Wind driven rain is even more troublesome at these locations without protection.

Several layers of sealant were discovered, many of which are cracked, deteriorated and failing. For sealant to be effective, it must be installed continuous, bonding to all surfaces. Old sealants and residue must be thoroughly removed prior to the application of new sealant to provide proper bonding. To make the situation worse, there are no provisions for drainage of the EIFS present at any transitions to the SSMR.

Infrared (IR) thermal imaging scans should be conducted at all membrane roof areas to determine if and where wet insulation is present. If wet areas are identified, they will require removal and replacement prior to installation of new roofing membrane. For the SSMR, since both the exposed layer and under roof deck are both metal, this assembly is virtually impossible to perform accurate IR scans to either from the top or the underside. Typically, if there are any areas of water infiltration on the SSMR, they will be located in transitions and flashings which can be disassembled and corrected during the fastener and sealant replacement work.

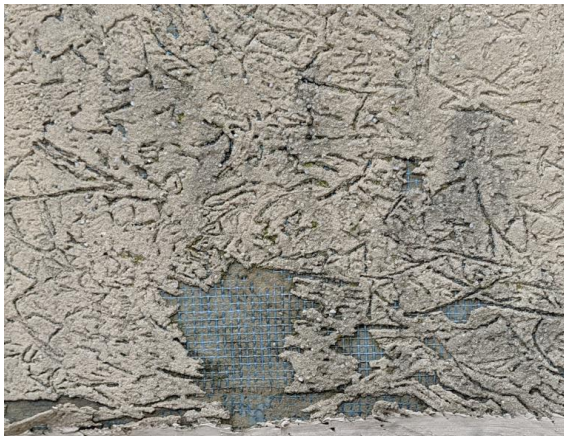
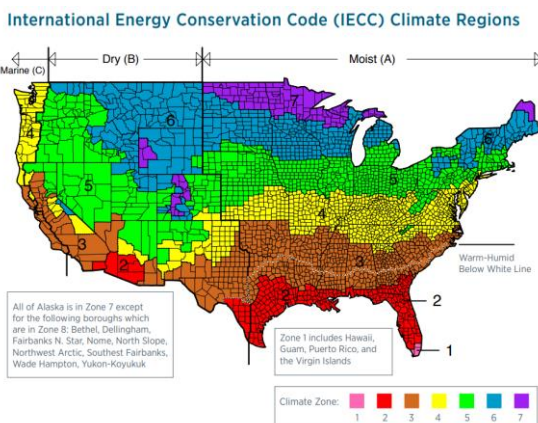
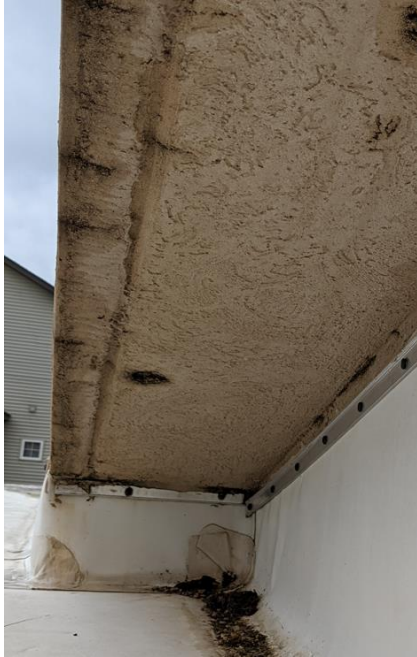
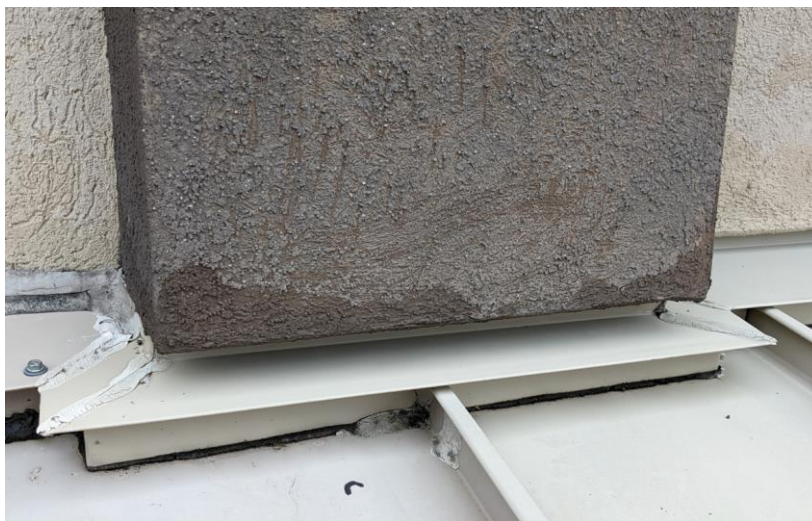
Drawings for the 1995 original building and the 2007 addition each indicate use of “drainable EIFS”; however, during our investigations no drainable systems were discovered. An EIFS assembly with no moisture drainage provisions is considered a face-sealed type of system and is designed primarily to keep moisture from penetrating the EIFS assembly itself through protection provided from the exposed finish coat. This type of system focuses on preventing moisture in the form of precipitation from entering at the exterior and without provisions for dealing with vapor infiltration from within the systems itself.

Due to the library’s location in Chatham Illinois, the Department of Energy and International Conservation Code (IECC) classify this area as Climate Zone 5, which is both moist and cold. What does this mean for your facility? It means this particular climate only allows for limited drying potentials due to the high relative humidity levels that exist throughout the year. This inherently creates an inadequate drying condition for EIFS where moisture sensitive components are used without provisions for drainage.

When the rate a material is exposed to moisture (commonly referred to as "wetting") exceeds its ability to dry, moisture accumulates. If this occurs to a material or system, EIFS in particular, and the level of accumulation exceeds safe and tolerable capacity for moisture storage within the assembly, deterioration occurs as the moisture contributes to breakdown of the material. The rate of "wetting" for a building is a direct function of exposure (e.g., sun, wind, heat, cold), design, construction, operation, and maintenance.

The main source of moisture affecting a building exterior is precipitation (in moisture form such as rain, snow, etc.); however, water vapor is also transferred through the air. Once moisture in the form of vapor encounters a surface below the dewpoint condensation occurs. Wind and air movement created by HVAC systems transfer positive and negative pressures carrying vapor into the wall assemblies. Since a face-sealed system does not ventilate, if any moisture enters the system, it becomes trapped within.

As the system ages and continues cycling through the extreme heat of summer and drastic winter cold of we experience here in Central Illinois, moisture and/or vapor combined with other previously referenced environmental factors, the system weakens and eventually will fail. During our investigation we found several areas where this deterioration has reached the point of failure since there is no way for water to vacate the

assembly. Once this occurs and topcoat fails, reinforcing mesh is exposed in the base coat. The extent of damage can only be realized through destructive investigation or demolition.

Due to the extent of deterioration and water infiltration present our recommendation is to remove the existing EIFS assembly in its entirety. Once the existing EIFS assembly has been removed all foreign adhesives and other existing contaminants must be thoroughly removed from the existing exterior wall sheathing. All substrate wall surfaces must be inspected for defects including, but not limited to, joint failure, fractures, and holes. Once the substrate has been properly prepared, all new flashings must be correctly installed.

Modern EIFS assemblies provide provisions for proper drainage, commonly referred to as "Drained EIFS," and can be installed in all climates and exposures. If it is the library's desire to maintain the look of EIFS, our recommendation is for installation of a new truly drainable EIFS assembly or with an entirely new wall cladding assembly such as insulated metal panels.

Based on the existing documentation, it appears a plastic vapor barrier is present in the wall assemblies; however, it is unclear of the exact location within. Assuming the vapor barrier is located directly behind the painted interior gypsum wall board, and due to the degree of disintegration observed, we recommend installation of a new breathable fluid-applied air/vapor barrier directly over the existing, and repaired, substrate prior to installation of a new cladding.

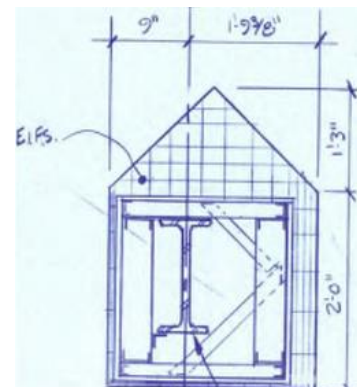
The last EIFS condition observed are at the east to west spanning "Architectural Elements" with concrete buttress bases, located on the north building façade. Again, this appears to have been clad without a drainable EIFS system and therefore there are no provisions for either ventilation or water to evacuate the system. Other than discoloration and accumulation of dirt and other organic material on the surface, this EIFS is in relatively decent shape. This is likely a direct result of their curved and pyramidal geometry.

EIFS at the architectural elements can either be cleaned and refurbished or replaced its entirety. If refurbishment is selected proper ventilation will need to be installed on the underside and run continuous from the base to the highest points, respectively. Expansion joints will need to be added where surface cracks are present, which will require additional framing and patching.

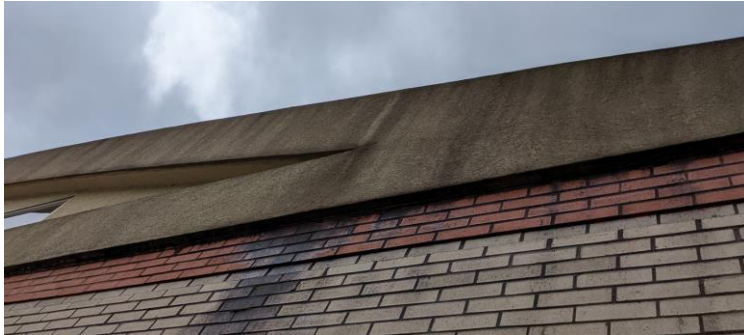
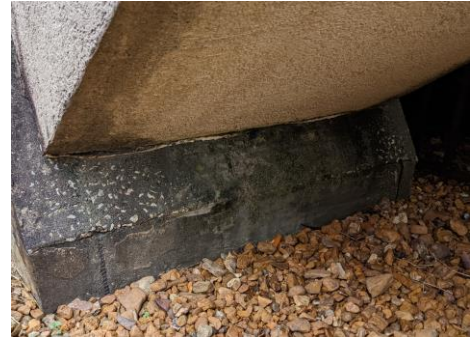
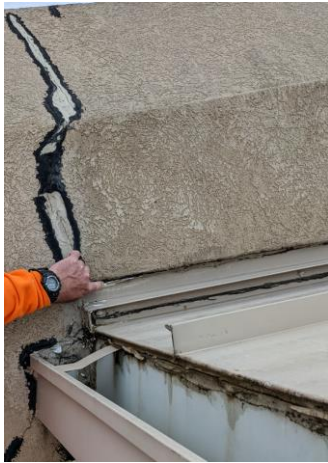
Discoloration of the EIFS and lower brick will continue to occur at the architectural elements without implementation of regularly scheduled cleaning. The following images illustrate the discoloration and terminations at the concrete buttress base.

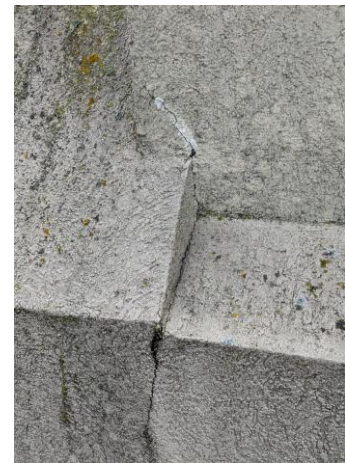
Surface cracks were found at various transitions where expansion occurs. Some cracks have been repaired with sealant; however, without a sufficient expansion joint to allow for both thermal movement and building contraction and expansion, the cracks will forever continue to worsen and fail allowing moisture to enter the assembly. And without a way to vacate the system, deterioration of the EIFS will continue and eventually deteriorate.

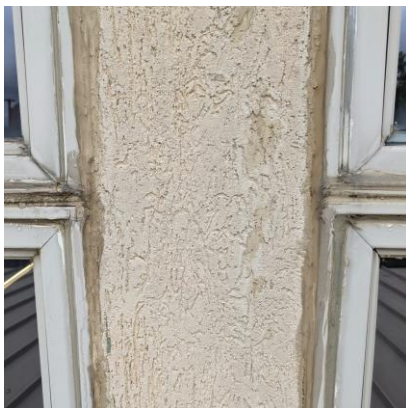
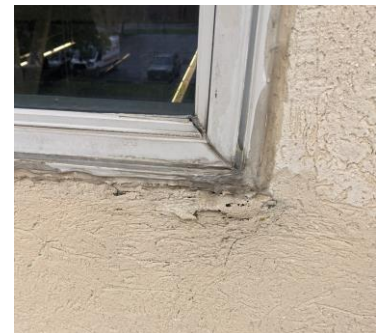
The existing clerestory windows are believed to be wood clad windows manufactured by Andersen Corporation, Architectural (A-Series). This style of windows is a residential type commonly utilized in both homes and light commercial. Unfortunately, they have visibly exposed openings in the frames, glazing stops and sealant transition to the EIFS. Commercial window systems incorporate water management systems that allow the units to ventilate and properly mitigate any moisture that may enter the system

either from direct participation and/or water vapor. The existing window systems do not appear to have any such provisions. We discovered sealant joints attempting to keep water out, but actually have contributed to trapping water within the wall system. There were no issues reported or observed at the existing window assemblies located in the lower masonry walls.

Based on the age and current condition of the existing windows, our recommendation is for removal and replacement of all existing clerestory wood clad window assemblies in conjunction with the EIFS replacement work. New window assemblies should include new aluminum storefront type windows with 1" low-E insulated glass, weeps for water management, both metal and flexible thru-wall flashings, water proofing, backer rod and sealants. Although no water infiltration issues were reported at the existing storefront system assemblies, we recommend replacing the perimeter backer rod and sealant at each location due to their age.

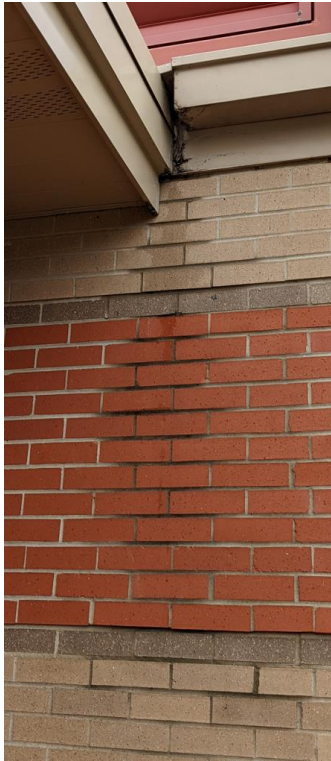
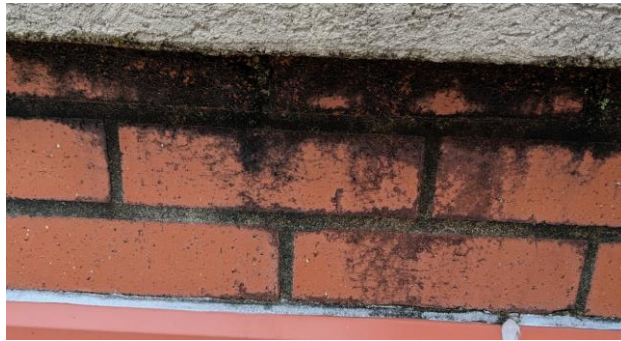
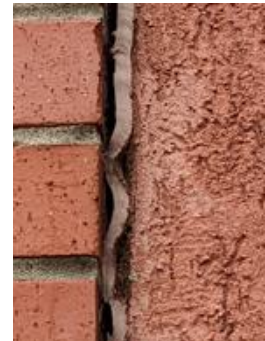
No specific exterior wall issues were reported regarding water infiltration; however, we did discover areas where sealant has failed and conditions where water runoff has stained the masonry below.

There were reports of water infiltration at the two planters located at both of the east entrance door locations. The water proofing membrane originally installed in 2007 is still in-place, but torn, allowing water to become trapped below weeps that were designed to let water escape. The weeps that do exist appear inadequate and possibly clogged. No records of new waterproofing being installed have been discovered, but staff did suggest there have been water

infiltration issues at these planters since the original building was constructed in 1995.

Finally, we recommend cleaning and sealing of the exterior masonry walls and replacement of all backer rod and sealant adjacent to and within the masonry wall assemblies. To correct water infiltration at the planters we recommend replacement and re-routing of the downspout drainage piping and installation of a waterproofing membrane system on the interior of each planter condition. An alternative would be to remove the planters in their entirety; however, this will require repair and treatment to the exposed masonry located directly behind the planters themselves.
