July 18, 2022

**Re: Building Leak Investigation Report**  
Chatham Area Public Library

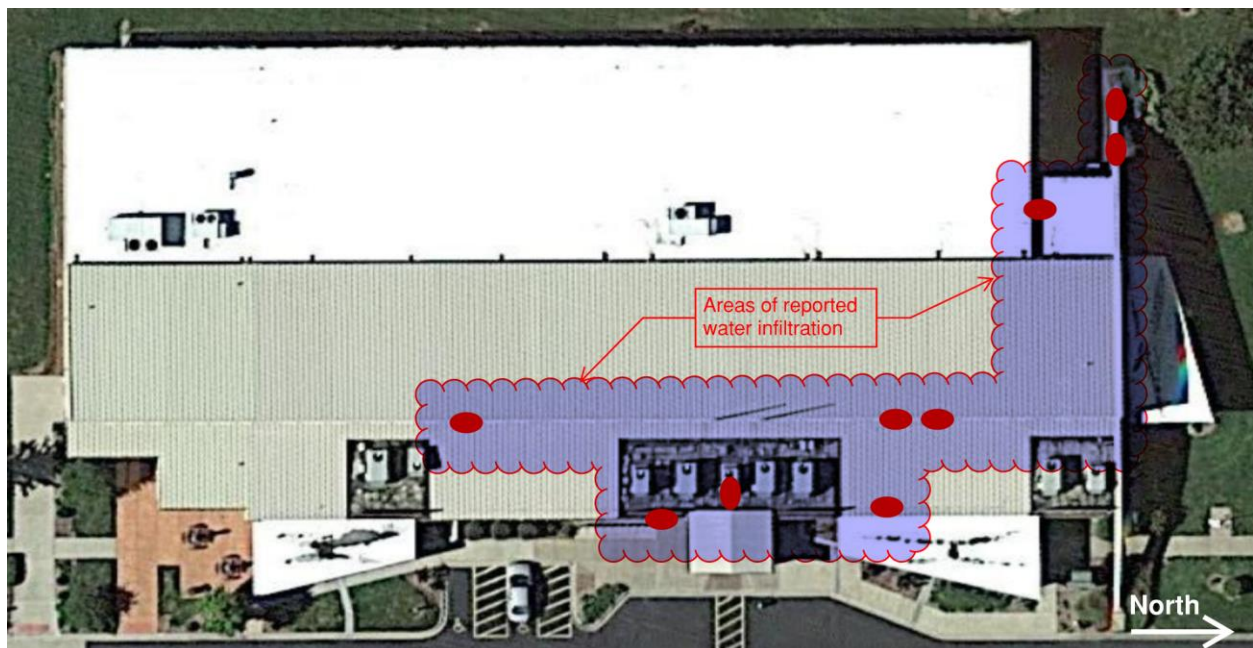
As per our agreement, Graham and Hyde Architects, Inc. (G&H) has completed the building leak investigation work. This report has been prepared based on on-site visual observation, conversations with library staff and review of existing construction documents provided by the client. In summary, we have discovered several poorly executed construction details including roof membrane terminations and flashings; EIFS (exterior insulation finish system) enclosures, drainage, and sealant conditions; and window enclosure details. The following satellite image documents where leaks have been reported by library staff in addition to problem areas discovered during our investigations.

These issues are further defined herein for the purpose of determining an order of magnitude for corrective work and establish the basis for cost of work which will be provided by O'Shea Builders.
